Title THE UNITED STATES
STRATEGIC BOMBING SURVEY #92

THE EFFECTS
OF
THE ATOMIC BOMB
ON
HIROSHIMA, JAPAN

Physical Damage Division

May 1947
PLEASE RETURN PROMPTLY TO
ROOM 326

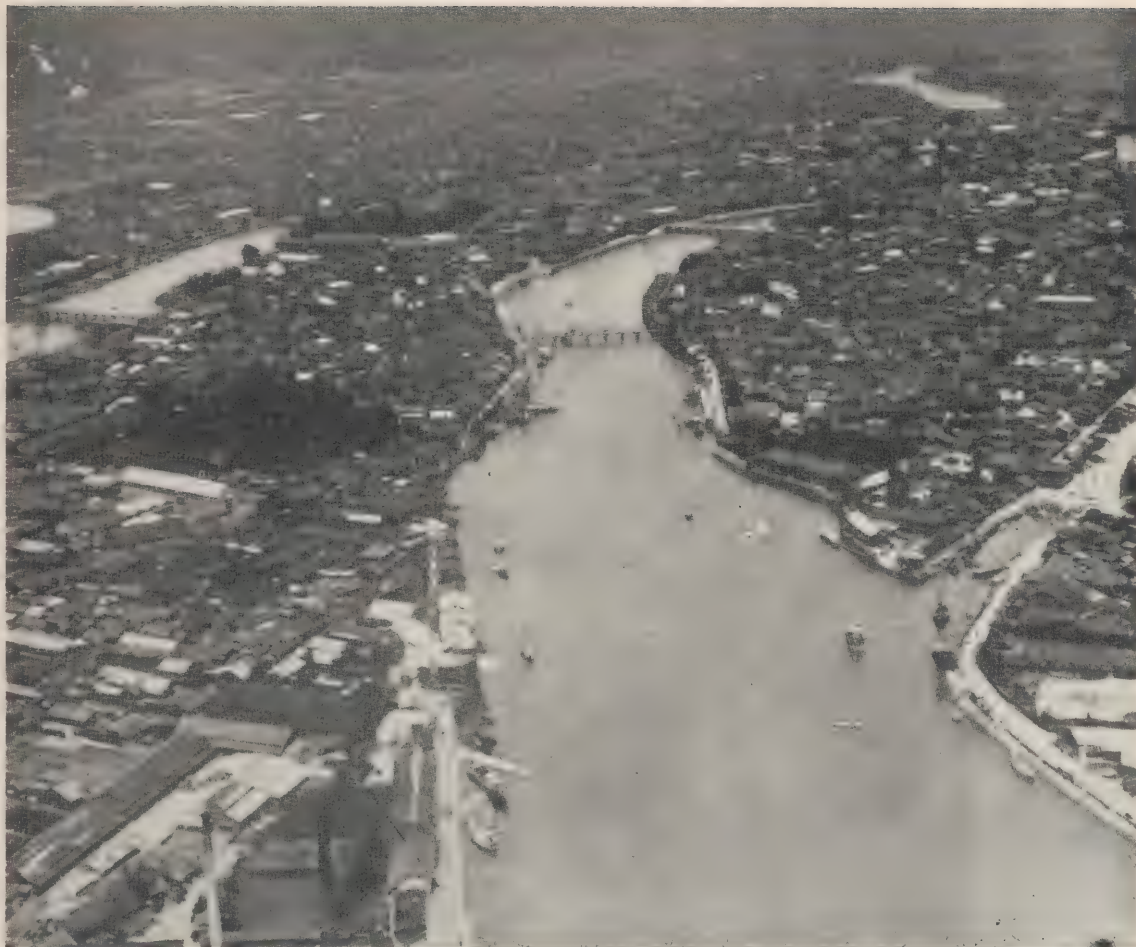
PHOTO 1-IV. Aerial view of the densely built-up area along the Motoyasu-gawa looking upstream. Except for very heavy masonry structures, the entire area was devastated. Ground zero of the atomic bomb was upper right in the photo, opposite the second bend in the river.

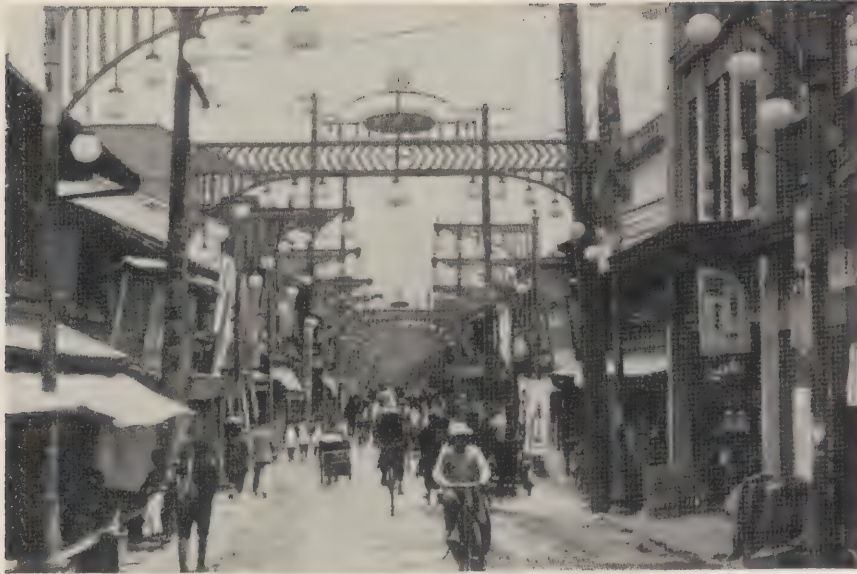
PHOTO 3-IV. Photograph of the downtown shopping district near the center of town. Only rubble and a few utility poles remained after the explosion and the resultant fires. This street was equivalent to the very famous Tokyo Ginza. Photo was taken facing east.

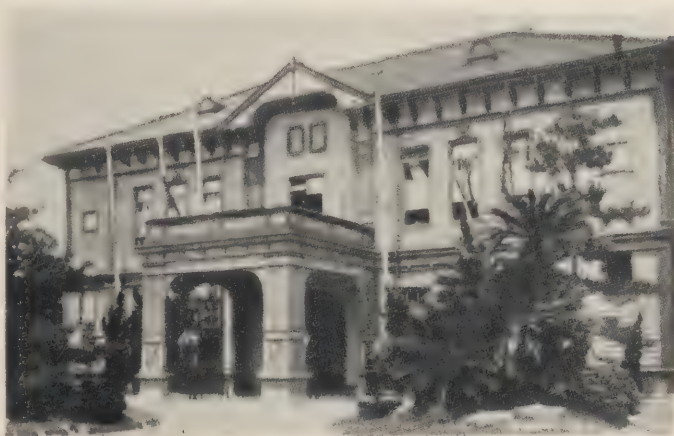
PHOTO 8-IV. HIROSHIMA UNIVERSITY OF SCIENCE AND LITERATURE, AND HIGHER NORMAL SCHOOL. The Higher Normal School was one of two such institutions in Japan. In 1929 the Hiroshima University was first founded and combined with the Normal School. This building located 4,500 feet from ground zero was completely destroyed.

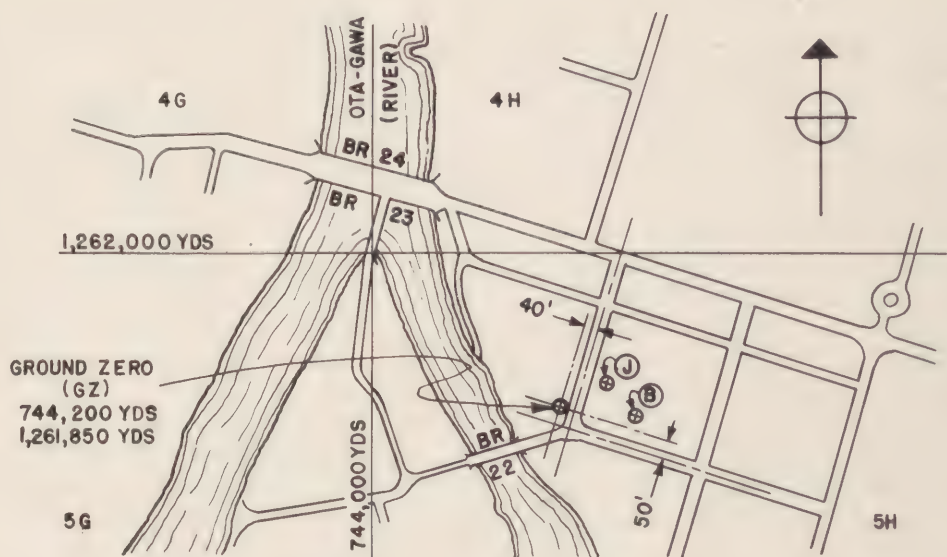
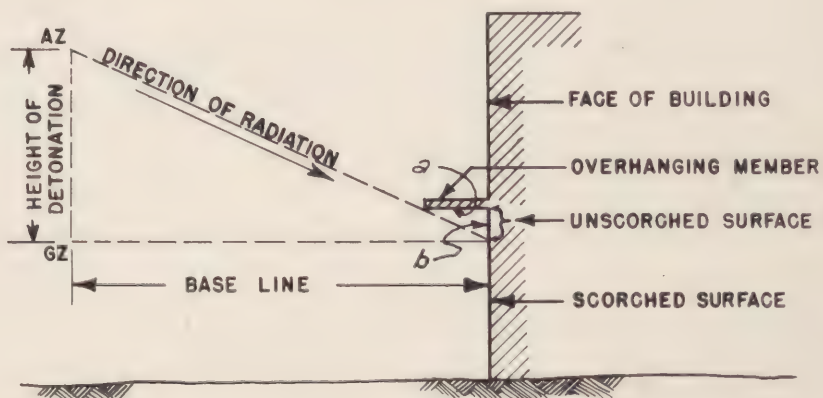
U.S. STRATEGIC BOMBING SURVEY
 DETERMINATION OF ZERO POINTS
 HIROSHIMA, JAPAN
 FIGURE I-VII

GZ was found to be in grid 5H at coordinates 744,200-1,261,850 (fig. 1). Air zero, determined from an average of seven computations, was found to be slightly over 2,000 feet.

Both AZ and GZ were determined from flash marks found on buildings, bridges, and other structures or objects. The flash marks resulted from the scorching of surfaces such as wood, asphalt, paint, or the spalling of granite from radiation of the intense heat of explosion. Objects obstructing the path of the heat wave cast their "shadows" which were actually unscorched areas. The edges of the "shadows" upon horizontal surfaces led to the location of GZ, and upon vertical surfaces permitted the computation of AZ. Photos 1 to 4, inclusive, show typical flash marks.

LOCATION OF GROUND ZERO (GZ) AS DETERMINED FROM FLASH MARKS.

TYPICAL CASE OF FLASH MARK USED IN COMPUTATION OF AIR ZERO (AZ).

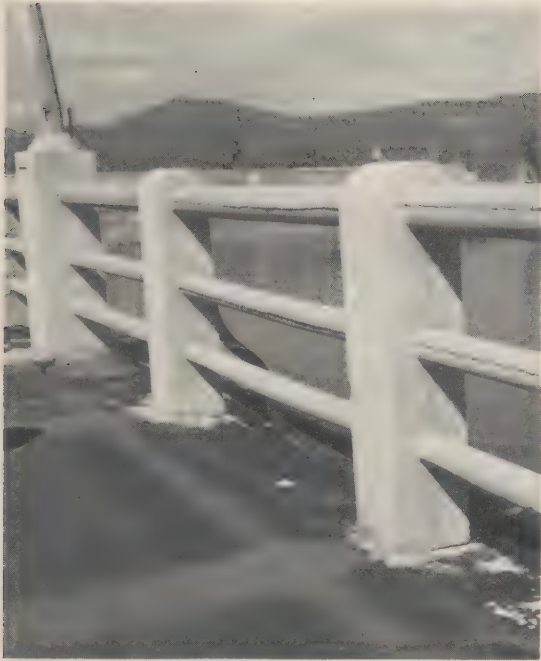
PHOTO 1-VII. Showing flash marks on asphalt deck of bridge.

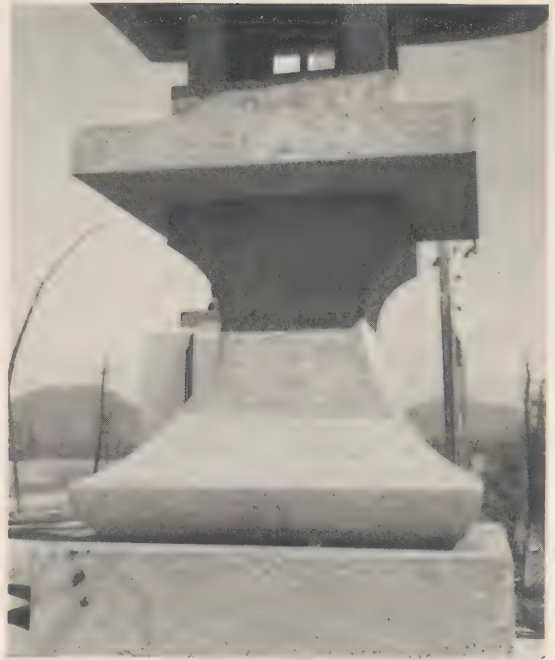
PHOTO 2-VII. Showing flash marks on granite lantern post.

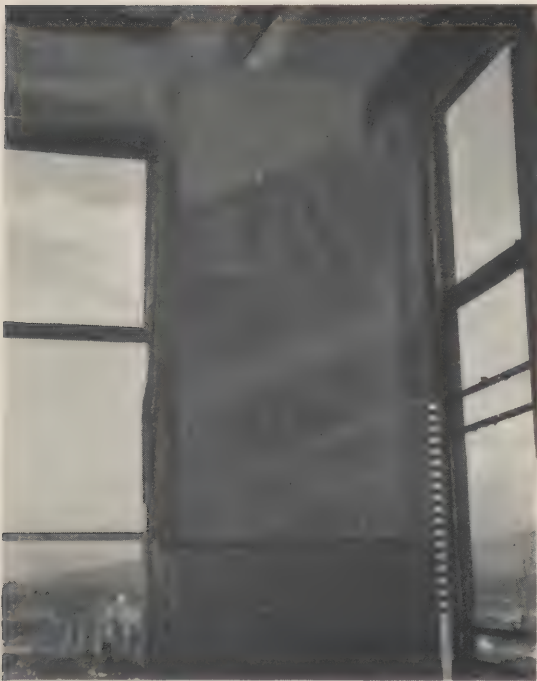
PHOTO 3-VII. Showing flash marks on celotex-type wallboard.

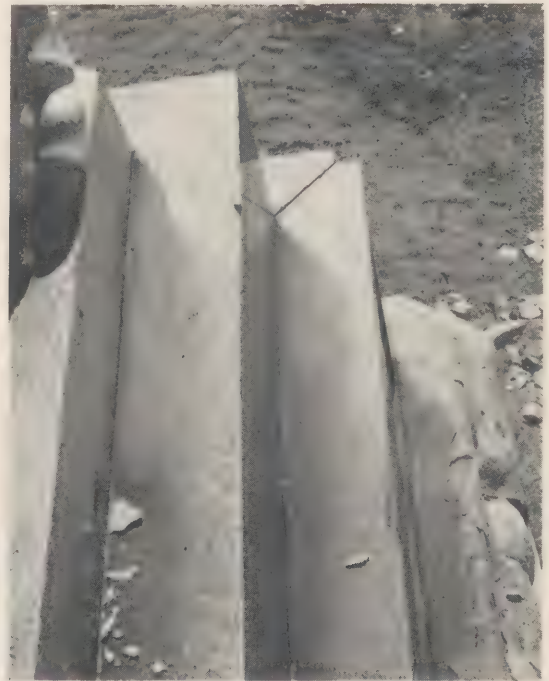
PHOTO 4-VII Showing flash marks on granite steps.

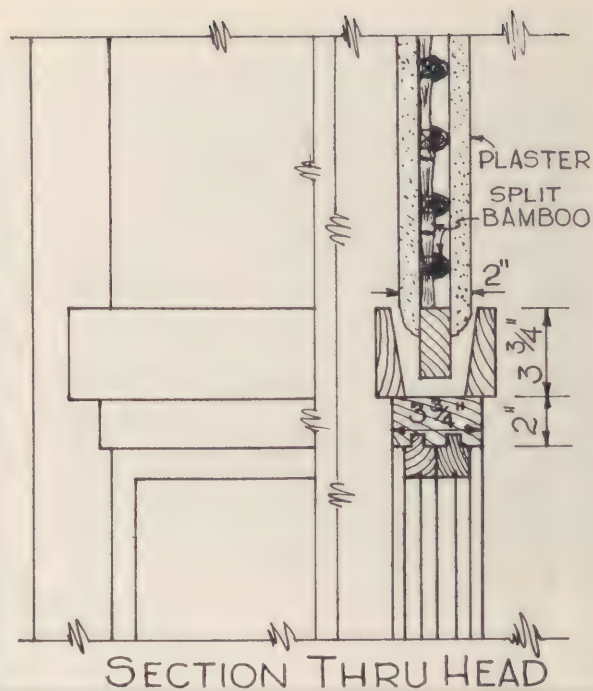
FIGURE 2-VIII. Japanese residence—Walls and partitions.

PHOTO 23-VIII. Damage to this typical wall panel has broken away the plaster and exposed the bamboo lath.

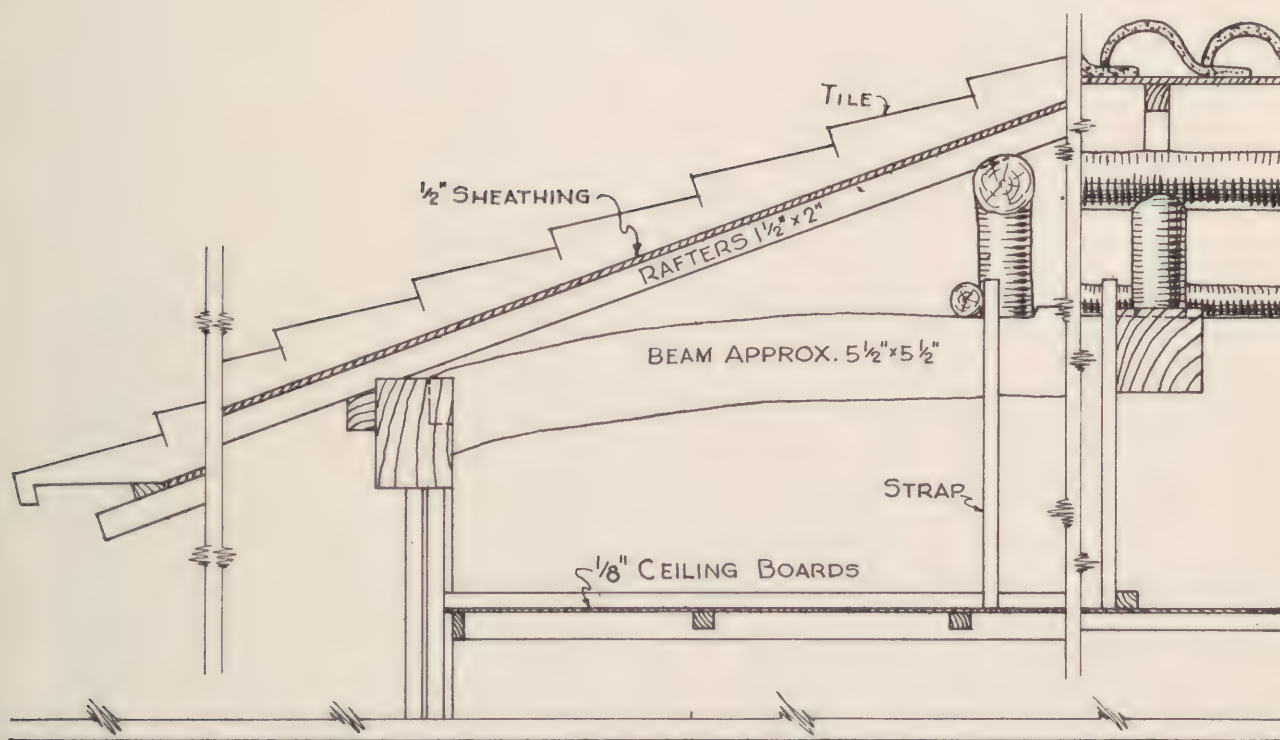
FIGURE 3-VIII. Japanese residence—Section through roof and ceiling.

PHOTOS 25-VIII and 26-VIII. These photos are interior views of a dwelling in which can be seen typical roof and ceiling construction. The drawing below further illustrates this type of construction.

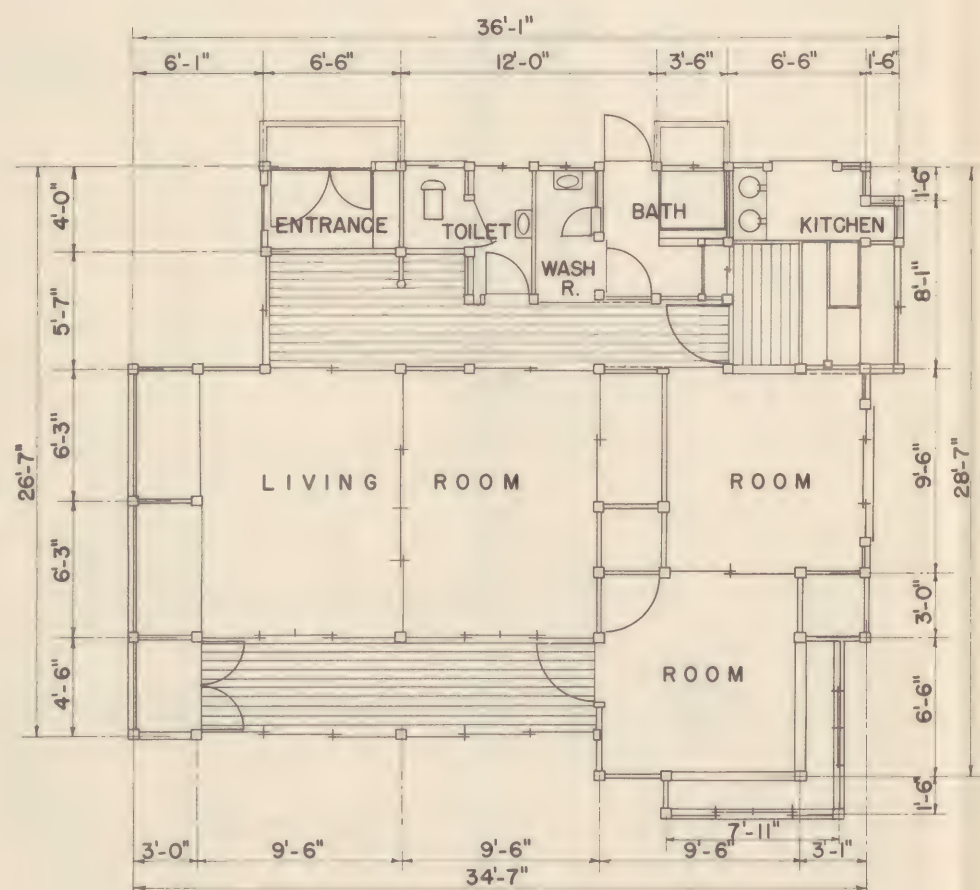
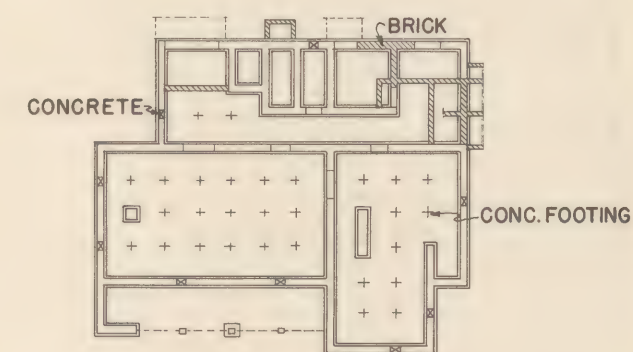
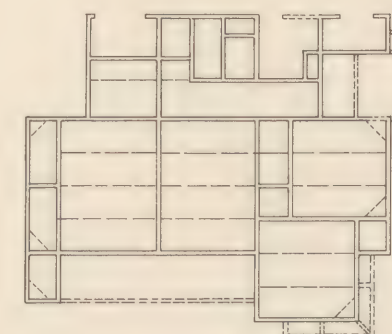
FIGURE 4-VIII

c. Frame (figs. 4 and 5). The frame of the dwelling consisted primarily of a heavy roof system, supported by 4- by 4-inch wood columns spaced about 6 feet apart around the exterior and along all major partitions. The exterior columns were framed into a heavy plate (usually about 9 by 9 inches). Heavy rough timber beams spanned the structure and supported the simple framing system of rough poles on which the purlins rested. Joints were usually mortise and tenon. No diagonal sheathing or bracing was used in the framing.
